BM515E / BM515M COMPARISON REPORT

UMK / SWARTKOPS TERMINAL

FEBRUARY 2016

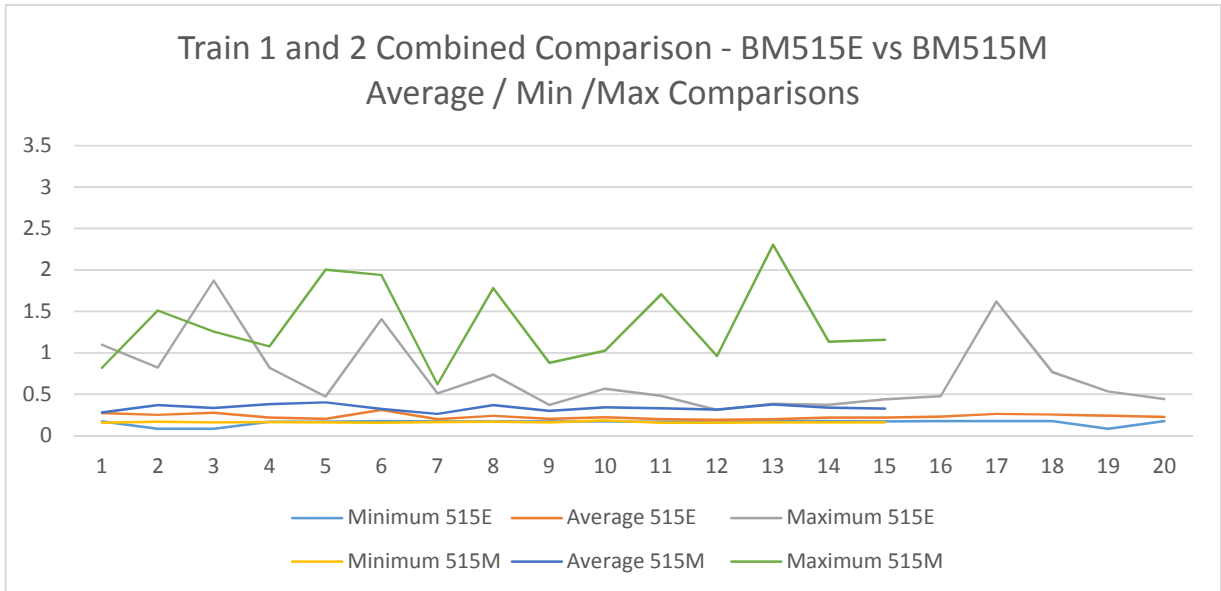
Figure 6.7. Train 1&2 - BM515E vs BM515M – Combined Performance Comparison

Due to the very low level of all the emissions, the difference is not extreme in nature, but tangible in terms of the emission data recorded. Although the variance is marginal, it is evident from the graphs presented in figures 6.3, 6.6, and 6.7, that BM515E performed better than BM515M on the two sample trains.

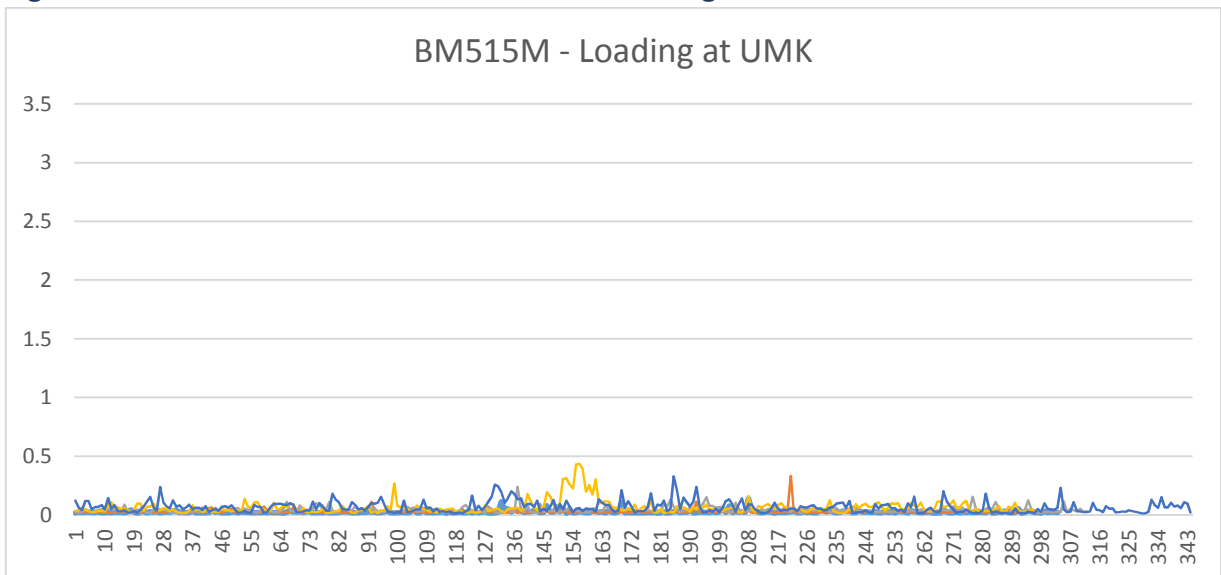
Figure 6.8. Train 1 - BM515M – Emissions while loading at UMK

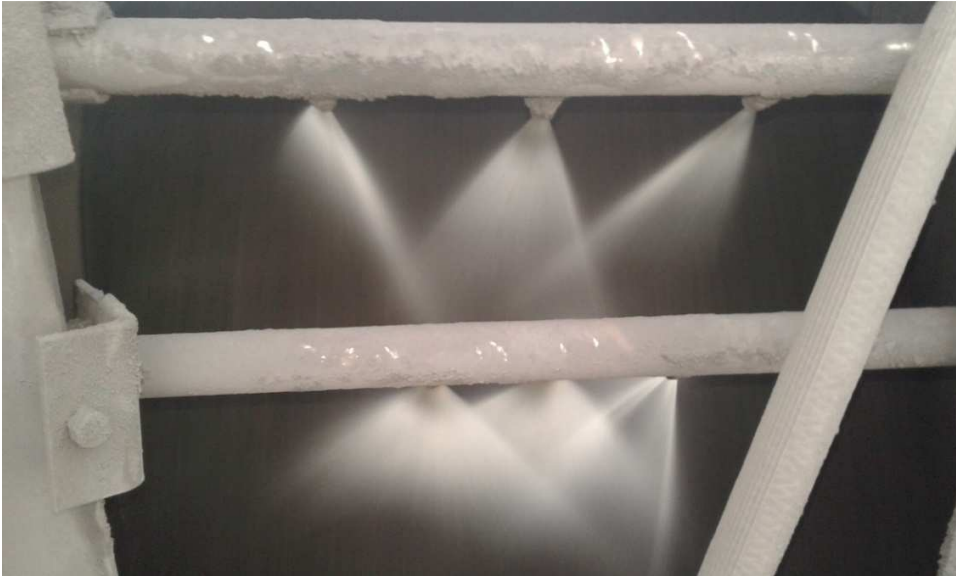
Figure 7.1. Treatment Manifolds at UMK

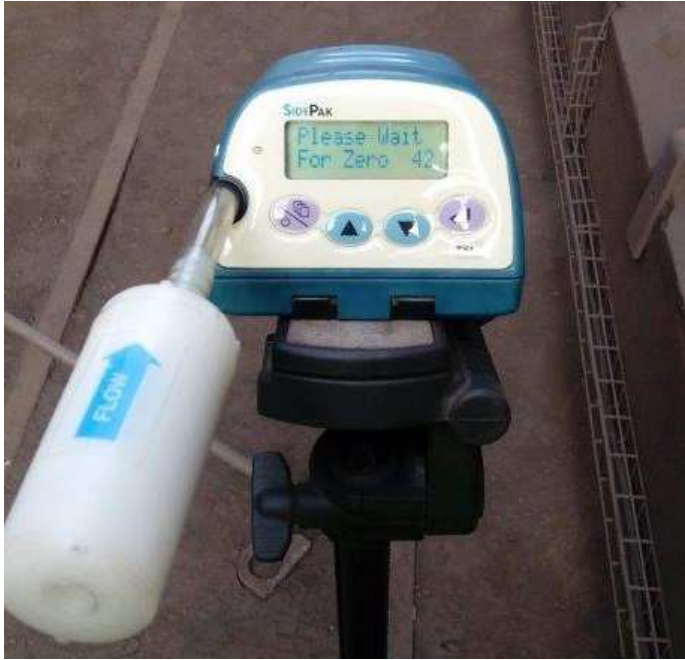
Figure 7.3. Calibration of Instrument at Swartkops

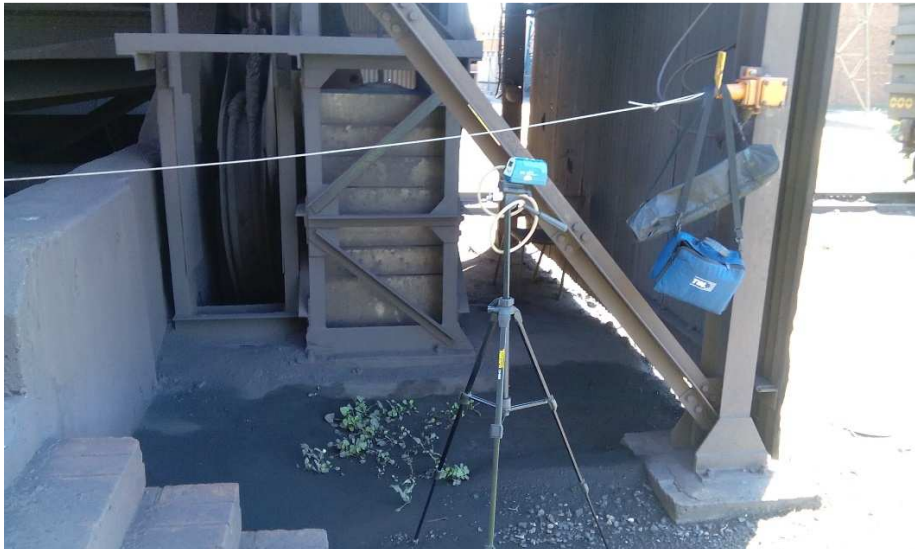
Figure 7.4. Instrument Placement at Swartkops – Downwind of Emissions

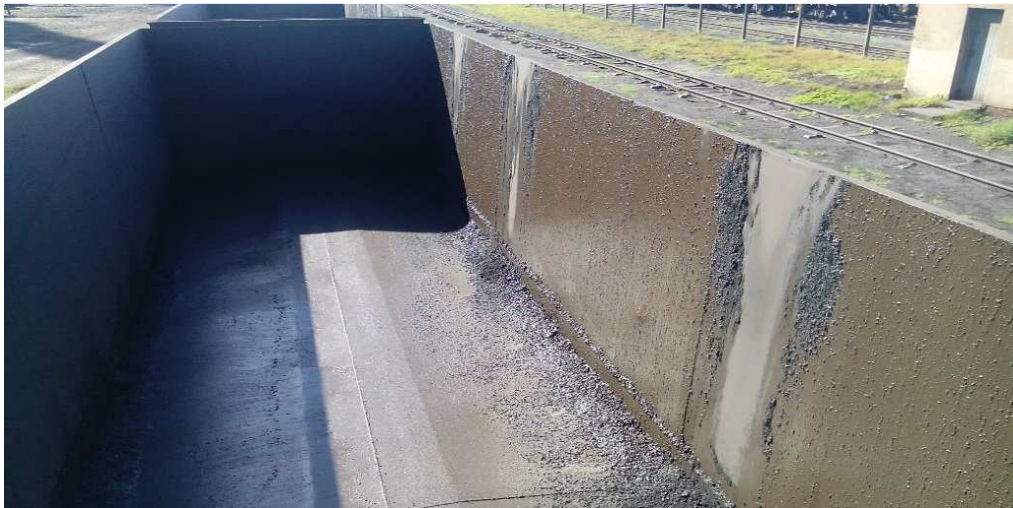
Figure 7.6. Residual material due to rainfall

The empty rail car in figure 7.6 above, gives an indication of the severity of the additional wetting caused by the rain, and it appears from this visual evidence that the amount of rainfall would have penetrated the material bulk to a depth where it would have an effect on the treated material and therefore the expected emission patterns.
