***DUST SUPPRESSION TEST REPORT***

***IDWALA LIME DANIELSKUIL***

***2 MARCH 2014***

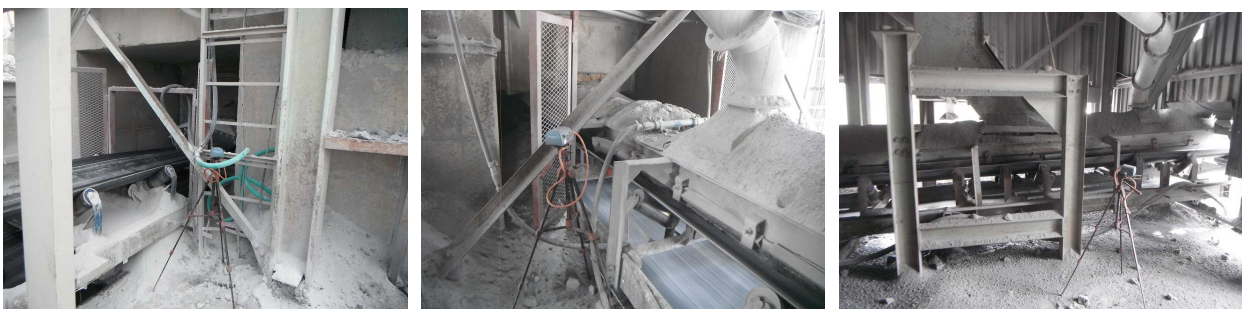
The sampling probe was set up at approximately 1.2m from ground level and 2m from points of emission – downwind.

The Pictures below show the placement of the sampling instrument and probe:

Sampling was only done while the crusher delivers. This is the stage when most of the emission occurs. As BC6 is the area that causes most of the dust emissions, 3 individual positions were selected for the placement of the dust monitor:

1. BC6 tail – crusher 1 discharge
2. BC6 mid – crusher 2 discharge
3. BC6 mid – fines bypass discharge

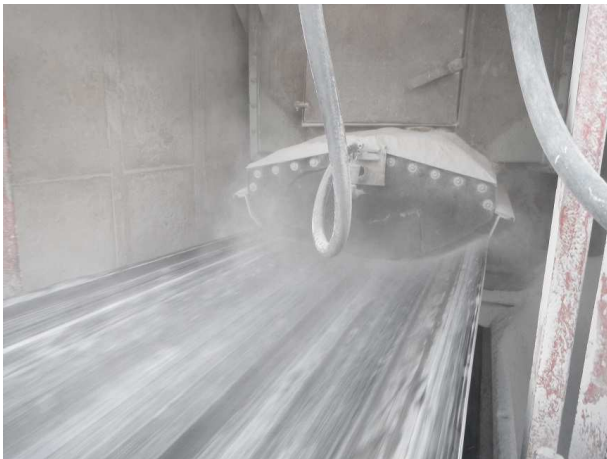
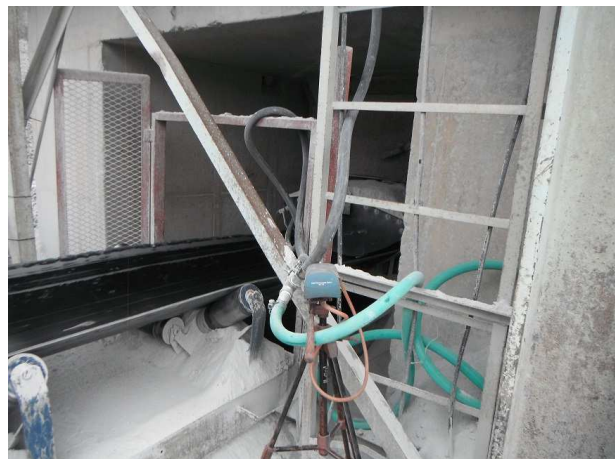
## BC6 Tail Crusher Discharge No Suppression vs Suppression

The results show a clear and dramatic reduction of measured and visible dust levels at all three positions. The effect is most visible on the three comparison graphs and accompanying pictures as displayed on the following 3 pages:

Test #1 – BC6 Tail Crusher 1 Discharge with suppression OFF

Test #5 – BC6 Tail Crusher 1 Discharge with suppression ON

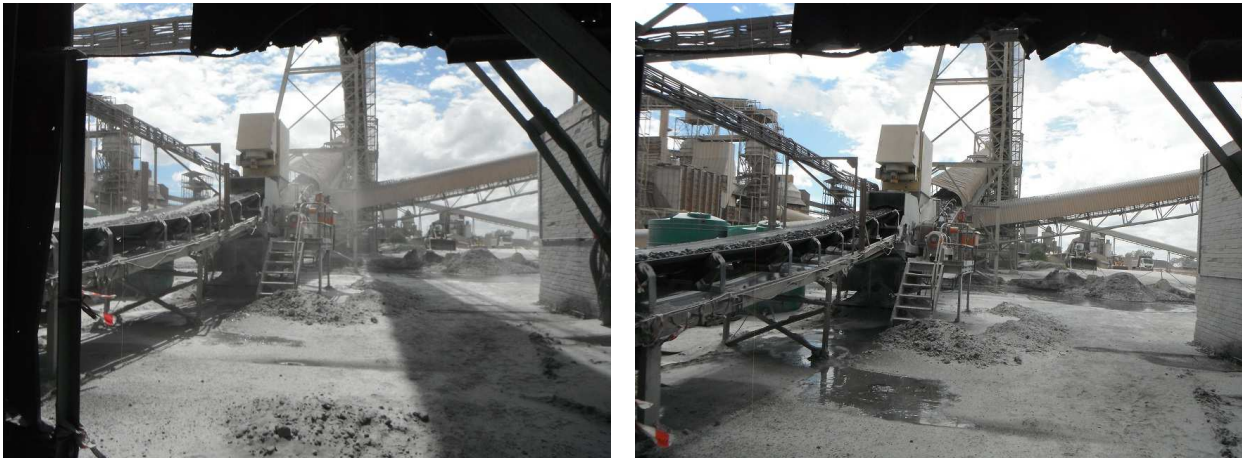
Of further significance is the benefit at downstream transfers as the pictures below indicate.
