## **Kolomela Dust Suppression Test Report 11 December 2013**

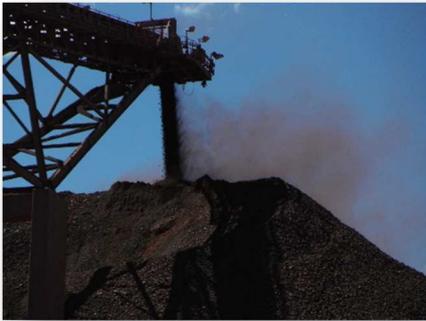
*Dustcon System On (only this picture refer to the Duscon system – all other pictures refer to Benmarc System only)*

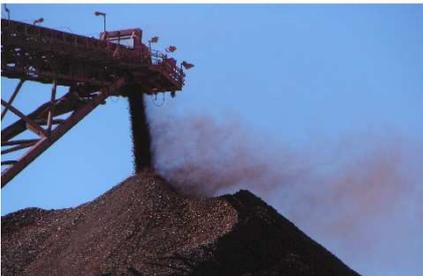
*System Off*

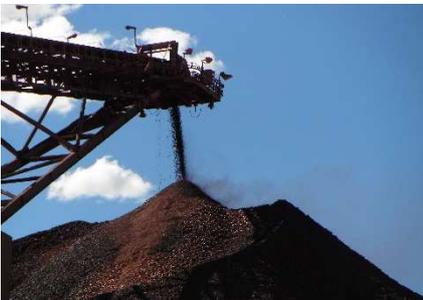
*System On + 15 Minutes*

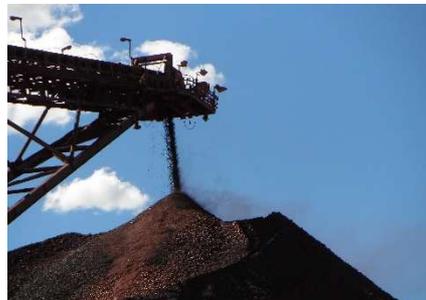
*System On + 15 Minutes + 30 Seconds*

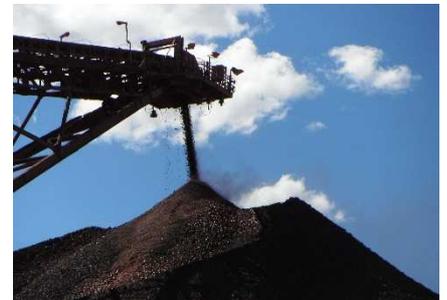
*System On + 25 Minutes*

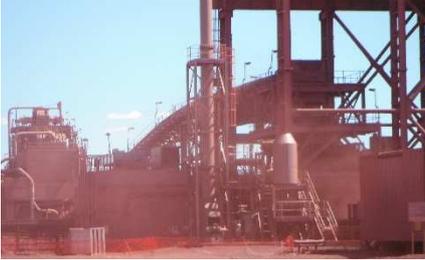
System Off

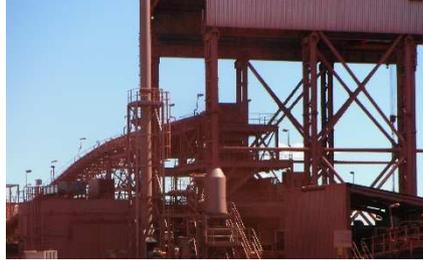
System On

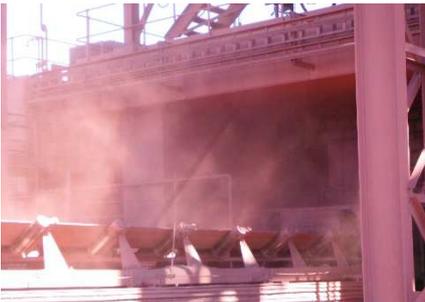
System Off

The following sequence shows the reduction of visible dust from system off, through system on, to full effectiveness after approximately 20 seconds (excluding benefit from oversize belt).

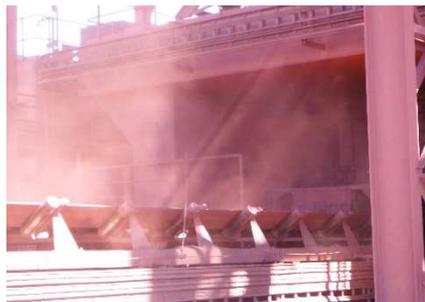
System On

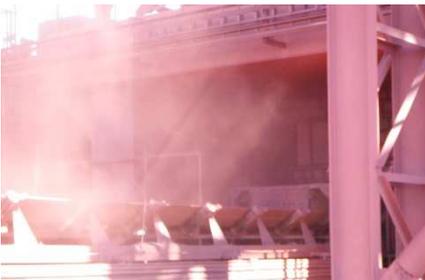
System On + 8 Seconds

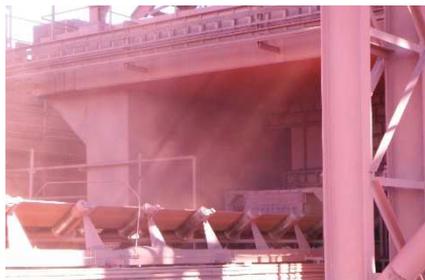
System On + 12 Seconds

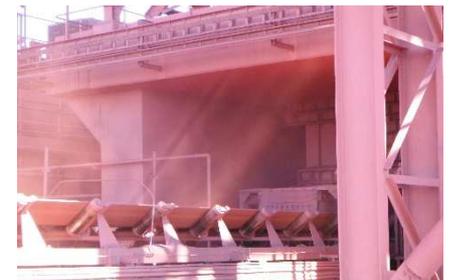
System On + 17 Seconds

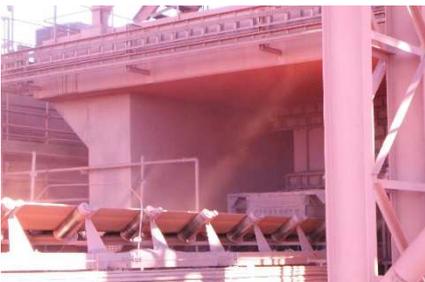
System On + 20 Seconds

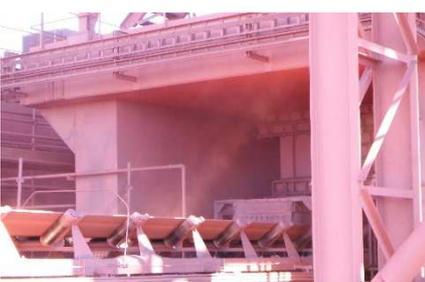
System On + 30 Seconds

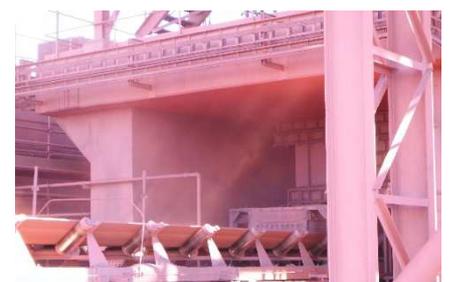
System on + 40 Seconds
